MEETING OF: **FINANCE COMMITTEE**
CALLED BY: JOE FRANK, CHAIRMAN
DATE: **NOVEMBER 12, 2018**
LOCATION: COMMITTEE/JURY ROOM
TIME: 6:00 P.M.
RE: ENERGY EFFICIENCY PROJECT:
PRESENTATIONS FROM POTENTIAL
VENDORS (6:00PM- BREWER
GARRETT & 6:30PM- LEOPARDO)

Self-Funding Energy Efficiency Improvements

Roof Inspection / Repair Report

Title: Roof Inspection Report, Sections A-V

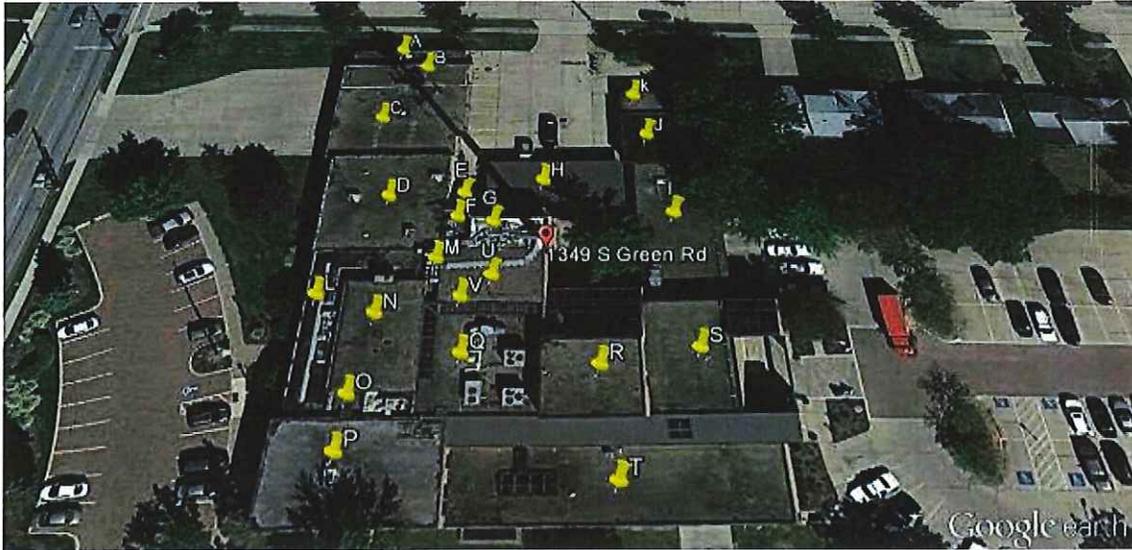
- Leopardo recommends sections A-D, Q, and U-V on the map below to be completely replaced. All HVAC, and other equipment shall be temporary relocated to accommodate the roof replacement as necessary. As the general contractor, Leopardo shall handle all coordination of sub-contractors to ensure a smooth and complete transition for the City.

- In addition to replacing roof sections, Leopardo recommends a comprehensive maintenance and repair plan for the non-critical areas of the roof. This would include repairing and replacing flashing, and spot-repairing leaks to extend the life of the non-critical roof areas. Doing these replacements and repairs would significantly reduce the current maintenance costs of this building. Energy savings would also be observed due to reduced infiltration.

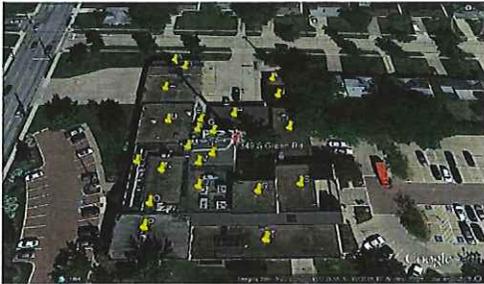
PHOTO 1

Overall roof photo. There are approximately 19 different roof sections; many of which are varying in age and condition. This is a very complex roof, meaning there is a significant amount of equipment present (HVAC and telecommunications). Many are very difficult to access.

Replacing numerous sections over the next 5 to 10 years needs to be seriously considered. A number of sections have well surpassed their life expectancy and if nothing is done, will turn into an emergency situation. Other sections have the ability to be restored. A roof restoration will cost a fraction of price versus a replacement and can add 10 years or more of life expectancy. The key factor is to act before the roof passes the point of no return.

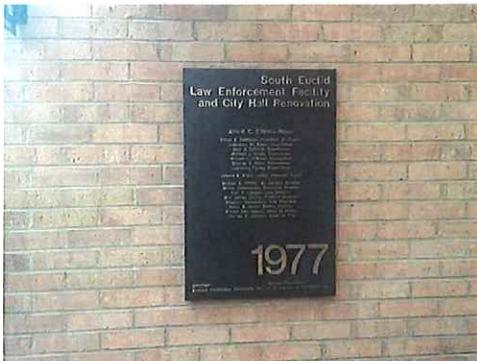
PHOTO 2

Many of the roof areas appear to be from the 1977 renovation. These have well surpassed their life expectancy and need to be replaced.

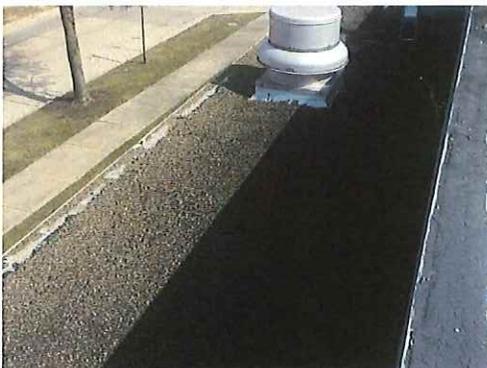
PHOTO 3

Section A – The perimeter is in need of maintenance.

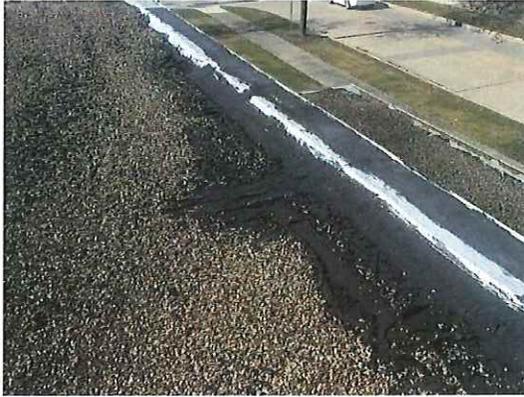
PHOTO 4

Section B – The perimeter is in need of repair and the roof has surpassed its life expectancy.

Unprotected Flashing Membrane: The flashing system of this roof is lacking a protective coating. The purpose of this protective coating is to extend the life of the roof by preventing UV deterioration. UV rays dry out the protective properties which cause the membrane to shrink and crack. Overtime, cracks will develop down into the depths of the felts, especially during the freeze thaw cycle. These cracks will eventually allow water to

enter the roofing system resulting in permanent damage.

Perimeter Flashing Deterioration: Most roof failures start at perimeter and penetration locations. Metal edge conditions that are poorly designed and improperly installed fail due to the extreme expansion and contraction that is typical with metal. Perimeter wall flashing can also be damaged due to normal seasonal building movement and thermal shock. Additional damage can also be seen from UV degradation as well. At all of these deteriorated or failed points, moisture can gain direct access to the roof system insulation and the building's interior.

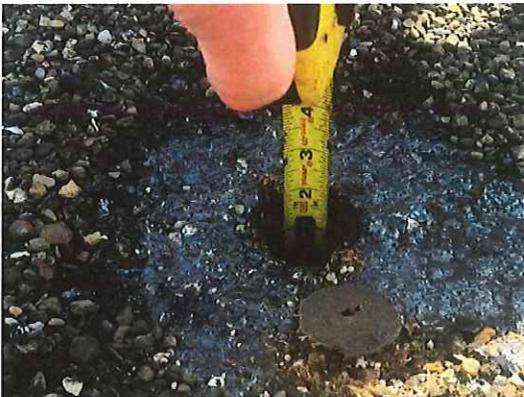
PHOTO 5

Section B – The core cut revealed tapered insulation and a flat roof deck. The roof is approximately 6.5" near the roof edge.

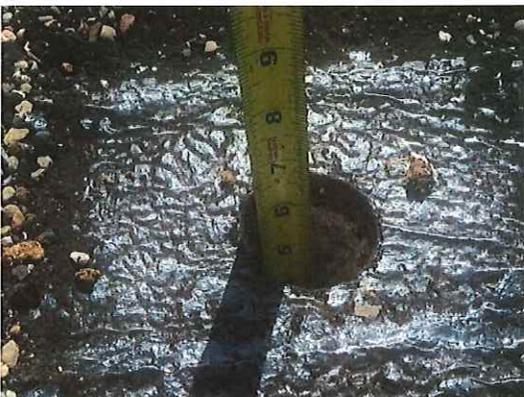
PHOTO 6

Section B – Approximately 2" near the drain.

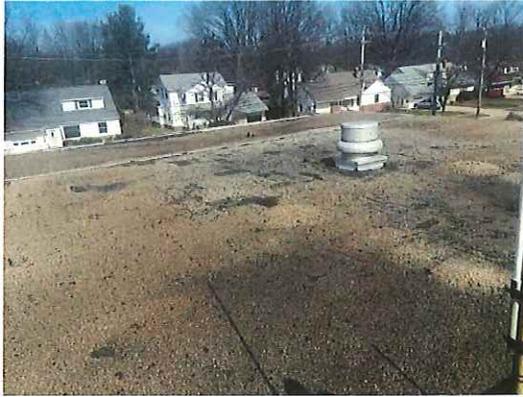
PHOTO 7

Section C-Overall this roof has well surpassed its life expectancy and needs to be replaced immediately. More expensive repairs will be needed if nothing is done. The following conditions exist:

Blisters: Soft sponge-like pockets or swellings in the roofing material. They occur between layers of felt or between the roof membrane and substrate. Air or moisture vapor entrapped within a blister expands as the roof and outside air temperatures rise. This results in sufficient pressure to push the roofing upwards and apart. Blisters may be ruptured by roof traffic, expanding frozen water, or hail (especially during colder weather). Some blisters may become so large where they affect drainage, which may cause ponding water. Laps could also be pulled apart, resulting in leakage. A ruptured blister will immediately allow water to penetrate and damage the roof system.

Perimeter Flashing Deterioration – Raised Metal Edge: Expansion and contraction movement of the metal edge causes a sawing action that cuts into the perimeter flashing. Moisture can then enter the roofing system and building. Moisture entry will cause damage to the insulation and reduce its insulating properties. It will also allow water to enter the building causing internal damage.

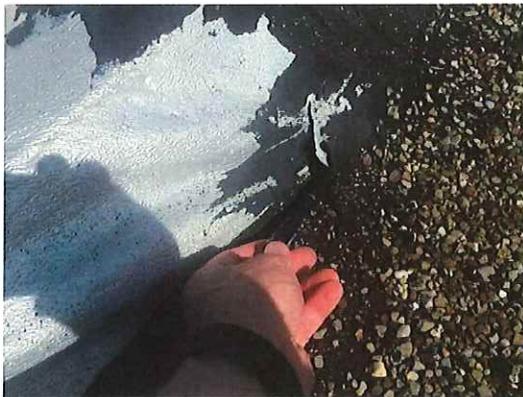
PHOTO 8

Section C- This is an immediate area for water to enter

Perimeter Flashing Deterioration: Most roof failures start at the perimeter and penetration locations. Metal edge conditions that are poorly designed and improperly installed fail due to the extreme expansion and contraction that is typical with metal. Perimeter wall flashings can also be damaged due to normal seasonal building movement and thermal shock. Additional damage can also be seen from UV degradation as well. At all of these deteriorated or failed points, moisture can gain direct

access to the roof system insulation and the building's interior.

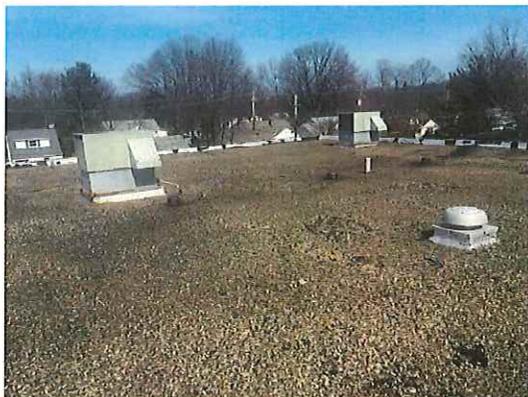
PHOTO 9

Section D-This roof has surpassed its life expectancy and needs immediate replacement. If nothing is done, more expensive repairs will be needed. The following conditions exist:

Perimeter Flashing Deterioration: Most roof failures start at the perimeter and penetration locations. Metal edge conditions that are poorly designed and improperly installed fail due to the extreme expansion and contraction that is typical with metal. Perimeter wall flashings can also be damaged due to normal seasonal building movement and thermal shock. Additional damage can also be seen from UV degradation as well. At all of

these deteriorated or failed points, moisture can gain direct access to the roof system insulation and the building's interior.

Blisters: Soft sponge-like pockets or swellings in the roofing material. They occur between layers of felt or between the roof membrane and substrate. Air or moisture vapor entrapped within a blister expands as the roof and outside air temperatures rise. This results in sufficient pressure to push the roofing upwards and apart. Blisters may be ruptured by roof traffic, expanding frozen water, or hail (especially during colder weather). Some blisters may become so large where they affect drainage, which may cause ponding water. Laps could also be pulled apart, resulting in leakage. A ruptured blister will immediately allow water to penetrate and damage the roof system.

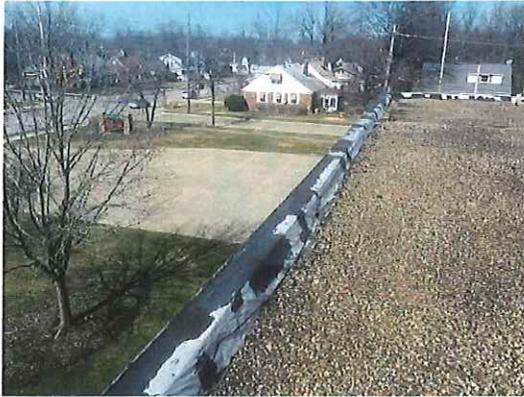
PHOTO 10

Section D

Unprotected Flashing Membrane: The flashing system of this roof is lacking a protective coating. The purpose of the protective coating is to extend the life of the roof by preventing UV deterioration. UV rays dry out the protective properties which cause the membrane to shrink and crack. Over time cracks will develop down into the depths of the felts especially during the freeze/thaw cycle. These cracks will eventually allow water to enter the roofing system resulting in permanent damage.

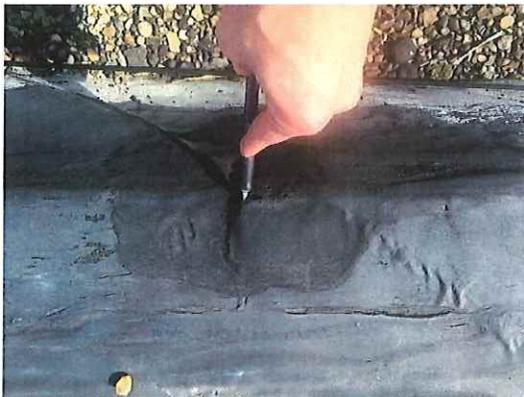
PHOTO 11

Section D – Close up of conditions

Perimeter Flashing Deterioration: Most roof failures start at the perimeter and penetration locations. Metal edge conditions that are poorly designed and improperly installed fail due to the extreme expansion and contraction that is typical with metal. Perimeter wall flashings can also be damaged due to normal seasonal building movement and thermal shock. Additional damage can also be seen from UV degradation as well. At all of these deteriorated or failed points, moisture can gain direct

access to the roof system insulation and the building's interior.

Unprotected Flashing Membrane: The flashing system of this roof is lacking a protective coating. The purpose of the protective coating is to extend the life of the roof by preventing UV deterioration. UV rays dry out the protective properties which cause the membrane to shrink and crack. Over time cracks will develop down into the depths of the felts especially during the freeze/thaw cycle. These cracks will eventually allow water to enter the roofing system resulting in permanent damage.

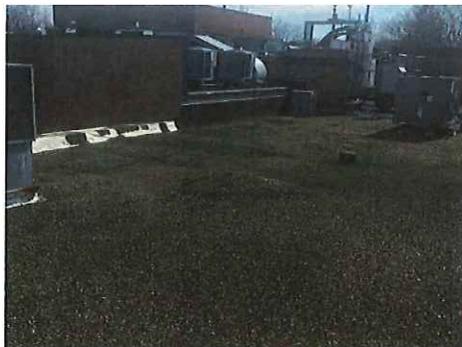
PHOTO 12

Section D – Area of a large repair

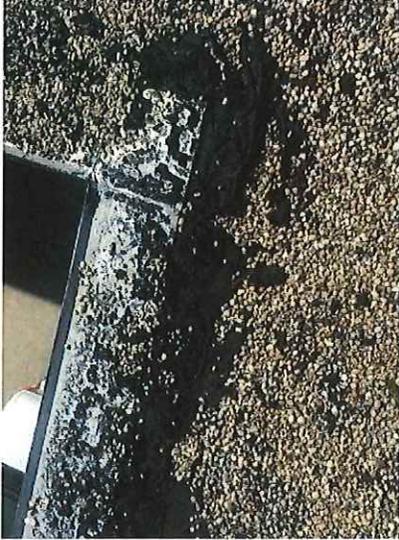
PHOTO 13

Section D – Close up of perimeter flashing deterioration. The protective flashing piles have completely worn away in this area.

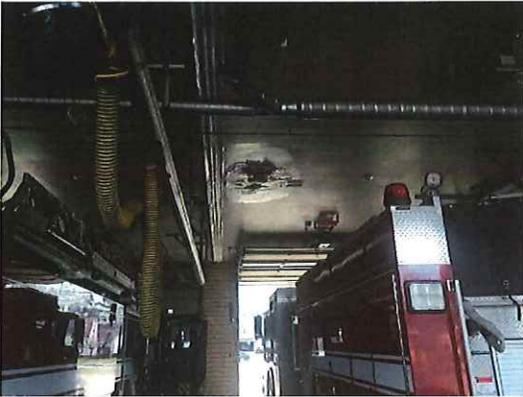
PHOTO 14

Section B, C, D - Significant leaks have been reported.

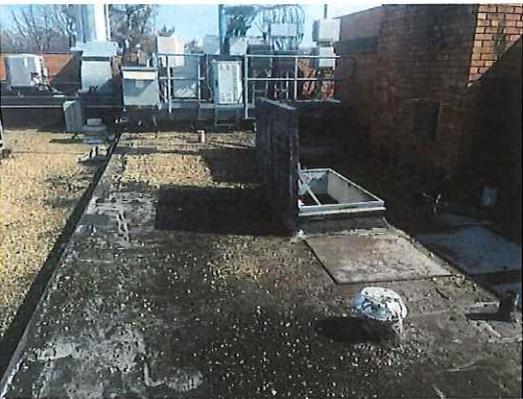
PHOTO 15

Section F - The telecommunications are located in this area.

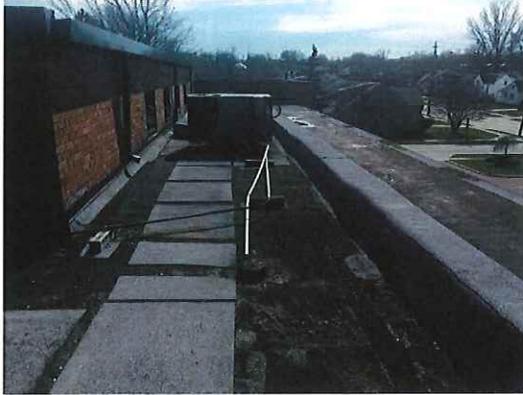
PHOTO 16

Section L – This roof might be a candidate for restoration. A thermal scan is required which will detect areas of wet insulation.

Unprotected Roof Membrane: The cap sheet of this roof is lacking a protective coating. The purpose of the protective coating is to extend the life of the roof by preventing UV deterioration. UV rays dry out the protective properties which cause the membrane to shrink and crack. Overtime, cracks will develop down into the depths of the felts especially during the

freeze / thaw cycle. These cracks will eventually allow water to enter the roofing system resulting in permanent damage. **Alligatoring:** A result of the drying out and shrinking of the asphalt surface resulting in a “mud-cracking” pattern. The pattern is most pronounced in areas of exposed asphalt. It is caused by the heat and UV rays of the sun beating down on the exposed asphalt surface. If left untreated, the Alligatoring condition can develop into splits in the roof membrane. As the surface continues to shrink and dry out, cracks will develop down to the depth of felts and may stress-crack the membrane in cold weather. These crack channels will allow water to penetrate and damage the roof system.

Bare or Exposed Felts: Weathering causes the roof’s surfacing materials to oxidize and wear away after a period of time. Loss of protection from the surfacing material results in accelerated deterioration of the primary water proofed asphalt, along with the system’s reinforcement piles which provide the strength for the system. Heat and UV rays dry out unprotected asphalt which then leave the bare reinforcement piles exposed to the elements. The exposed reinforcement will begin to absorb and wick moisture into the built-up layers of the roof system. This condition leads to accelerated damage via blisters and interlayer delamination. Roof system damage occurs when these weakened areas of the roof system are affected by thermal shock, typical roof traffic and normal seasonal conditions.

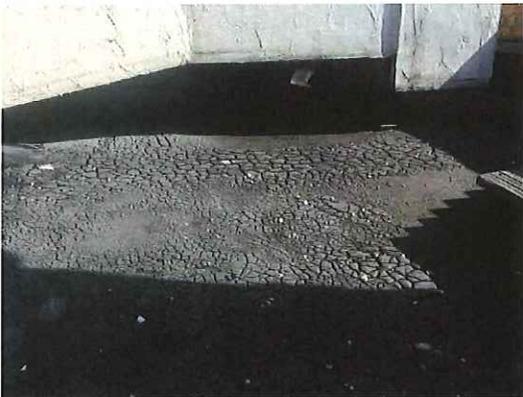
PHOTO 17

Section L – Close up of the Alligatoring.

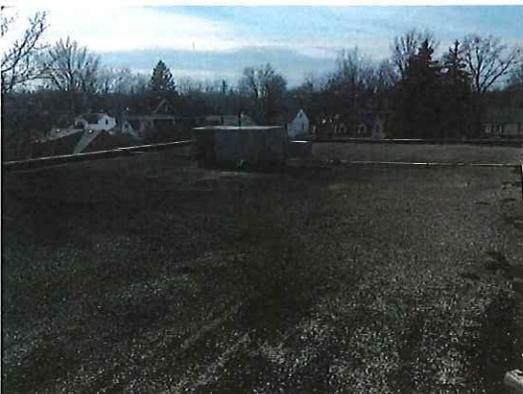
PHOTO 18

Section P – This roof might be a candidate for restoration. A thermal scan is required, which will detect the areas of wet insulation.

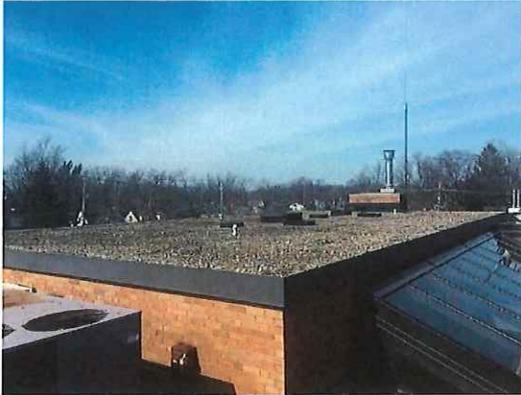
PHOTO 19

Section N – This roof might be a candidate for restoration. A thermal scan is required, which will detect the areas of wet insulation.

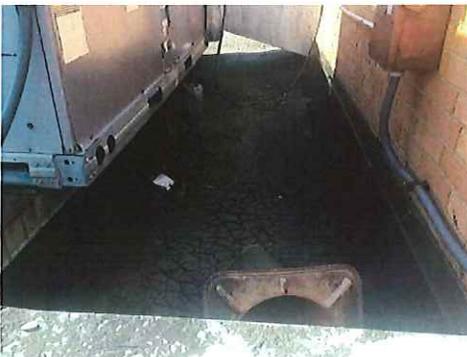
PHOTO 20

Section O – This will be a difficult roof area due to access and then HVAC equipment.

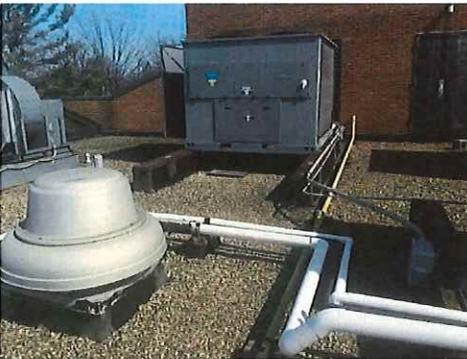
PHOTO 21

Section Q – Numerous leaks have been reported and the roof has surpassed its life expectancy. This will be a difficult roof area due to access and the HVAC equipment.

Unprotected Flashing Membrane: The flashing system of this roof is lacking a protective coating. The purpose of the protective coating is to extend the life of the roof by preventing UV deterioration. UV rays dry out the protective properties which cause the membrane to shrink and crack. Over time cracks will develop down into the depths

of the felts especially during the freeze/thaw cycle. These cracks will eventually allow water to enter the roofing system resulting in permanent damage.

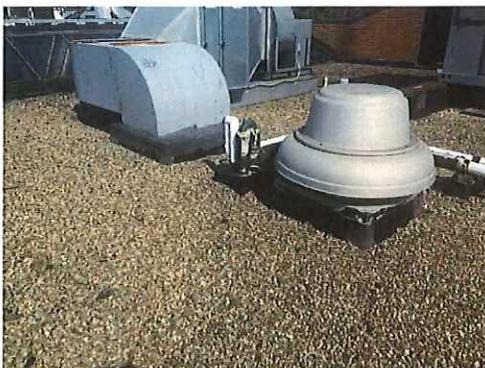
PHOTO 22

Section Q – Numerous leaks have been reported and the roof has surpassed its life expectancy. This will be a difficult roof area due to access and the HVAC equipment.

Unprotected Flashing Membrane: The flashing system of this roof is lacking a protective coating. The purpose of the protective coating is to extend the life of the roof by preventing UV deterioration. UV rays dry out the protective properties which cause the membrane to shrink and crack. Over time cracks will develop down into the depths of the

felts especially during the freeze/thaw cycle. These cracks will eventually allow water to enter the roofing system resulting in permanent damage.

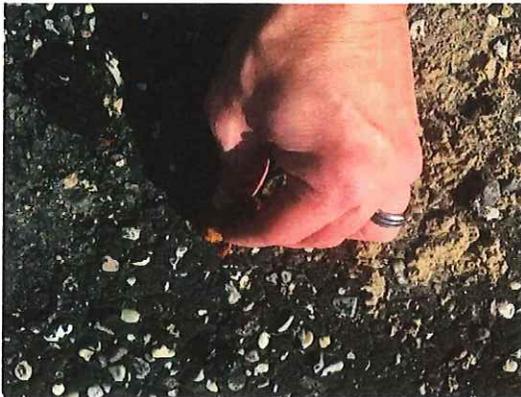
PHOTO 23

Section Q – A core cut revealed wet insulation.

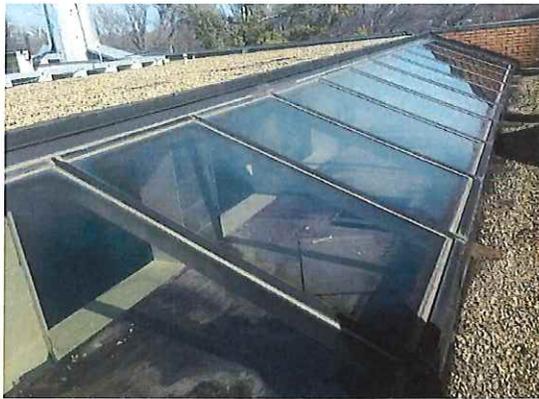
PHOTO 24

Section V – The skylights have leaked and continue to be a maintenance item. A ceiling has been added so they are no longer serving their intended purpose. The recommendation is to install metal panels to the lower section.

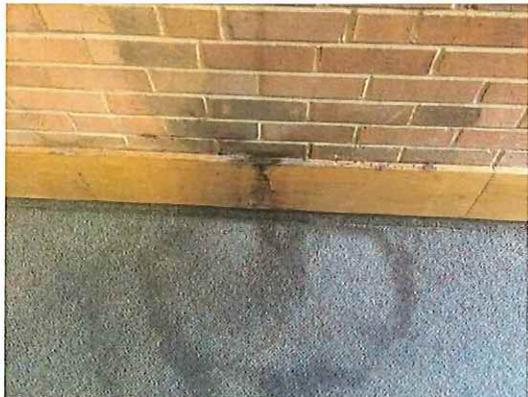
PHOTO 25

Interior Leak

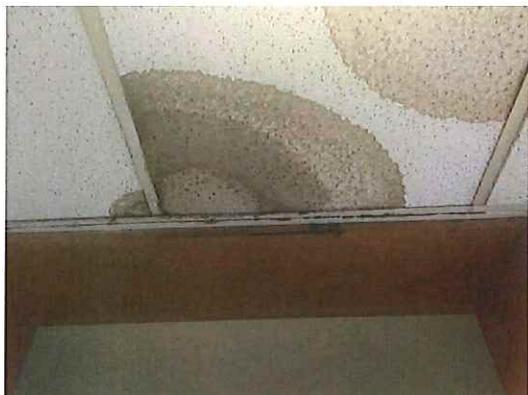
PHOTO 26

Interior Leak

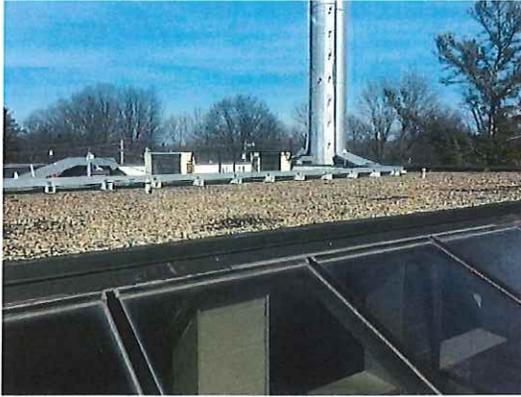
PHOTO 27

Section U – This will be a difficult roof area due to access. The roof might be a candidate for restoration. A thermal scan is required which will detect areas of wet insulation.

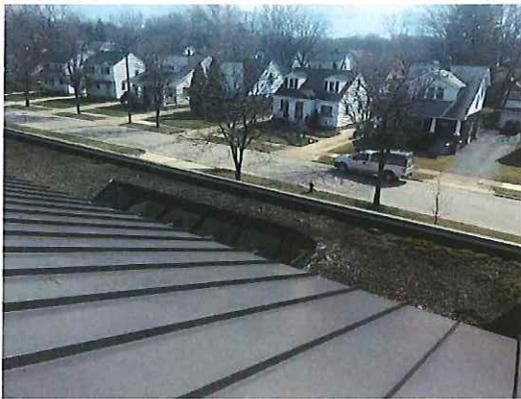
PHOTO 28

Section T – Close up of the metal roof panels that have been installed over the skylight. This roof might be a candidate for restoration. A thermal scan is required which will detect the areas of wet insulation.

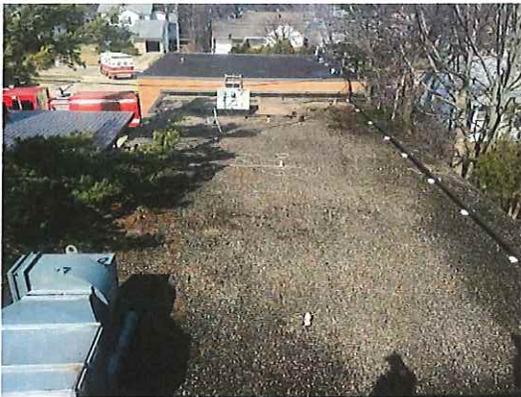
PHOTO 29

Section J & K- This roof might be a candidate for restoration. A thermal scan is required which will detect the areas of wet insulation.

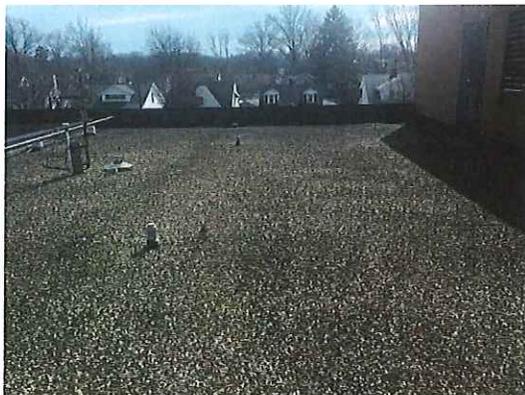
PHOTO 30

Section S – This roof might be a candidate for restoration. A thermal scan is required which will detect the areas of wet insulation.
